SERVICE INFO
LETTER

TITLE: 7.5" GATE INPUT SHAFT

SUBTITLE: RETAINING

NUMBER: GATE 02

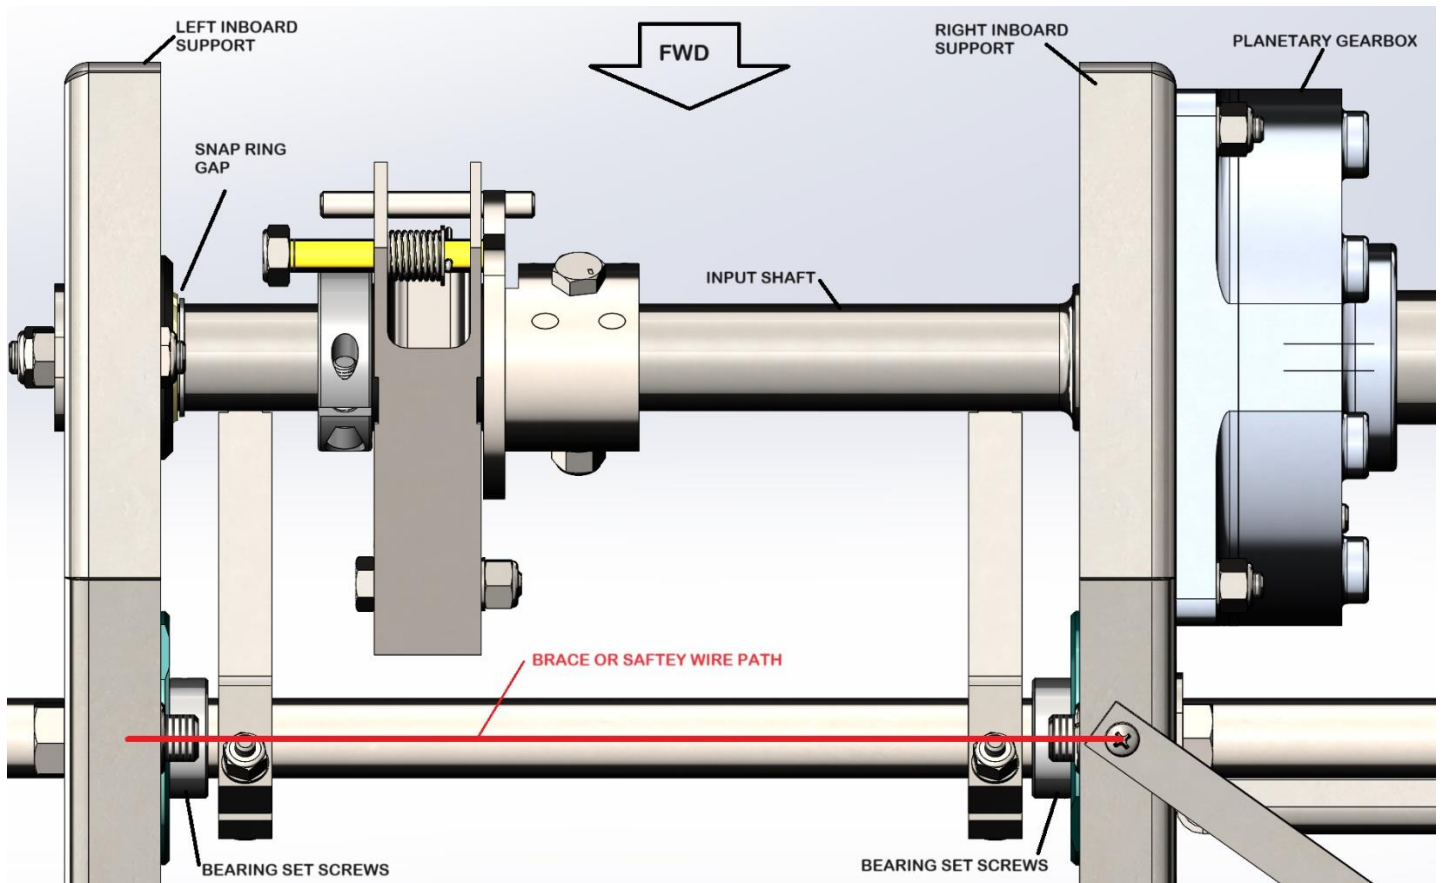
As an additional safety a cross brace or span of .051" dia Stainless Steel Safety wire may be used to connect the Left and Right Inboard Supports. (Path shown in Red)

View from bottom up of Input shaft on 7.5" Gate Assembly

To alleviate and prevent this problem, make sure Input Shaft (PN: 8-7-2-001) is fully inserted into the Planetary Gearbox (PN: 8-7-2-004), Check that there is no more than .050" gap between the snap ring on the Input shaft and 1" Flange Gearing (PN: 8-2-2-007) Check that Both Set screws on both .75" Flange Bearings are properly torqued per AC43.13-1B.
